# Transport of wheelchair seated passengers- providing evidence of the limits of tilt and recline in transport

**Bob Appleyard: Mobility Support Services.**

**Vicky Curling: Rehabilitation Engineer**

*Source: PMG Annual Conference*

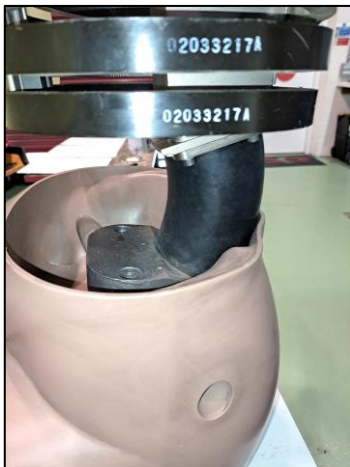
**Hybrid III 50<sup>th</sup> percentile lumbar spine  
with 7° to 9° anterior tilt**

When the automotive pelvis is used it is not possible to create the extents of open-hip angle by virtue of rotation of the pelvis around a transverse axis through the femur heads. Instead, a back angle representative of recline is achieved by distortion of the lumbar spine.

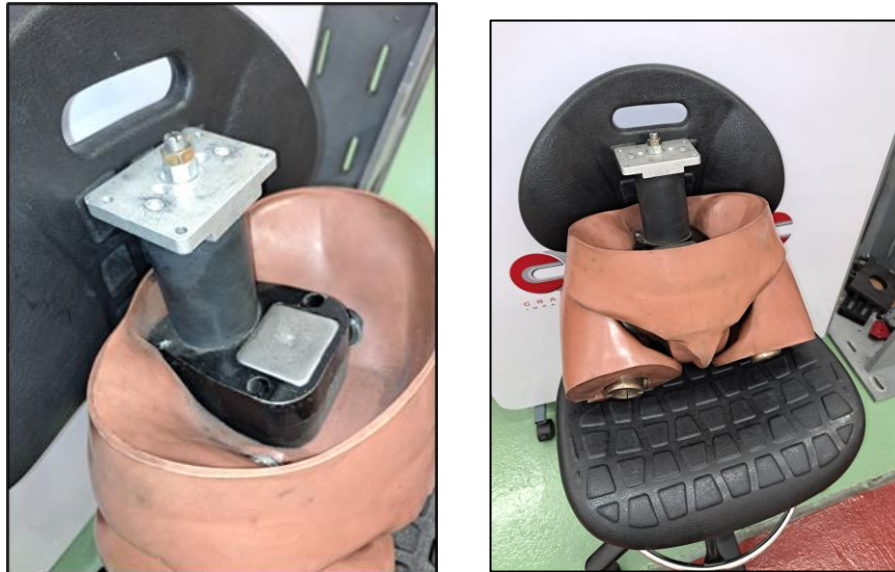
**Hybrid III 50<sup>th</sup> percentile standing pelvis.**

A Hybrid III 50<sup>th</sup> percentile ATD, mid-sized adult male of 77kg was used as a surrogate occupant in each dynamic test. In order to achieve the extents of open hip angle required to represent a human occupant, the Hybrid III 50<sup>th</sup> percentile was fitted with a standing pelvis, used in the assessment of ambulance stretcher occupant restraint systems where the ATD is supine. The Hybrid III 50<sup>th</sup> percentile ATD is employed to represent a vehicle seated occupant and has built into its lower spine region a 7° to 9° anterior pelvic tilt, which creates a commonly adopted seated posture for occupants in passenger vehicles, for both passengers and drivers.

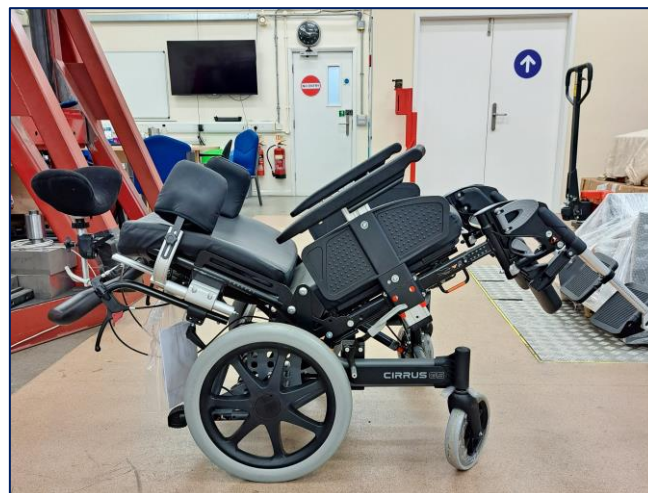
**Cirrus G5 at full tilt and recline**

Three Sunrise Medical Cirrus G5 products were donated to the project by Sunrise Medical. The Cirrus G5 has satisfied the requirements of ISO 7176-19 in an upright mode and is capable of achieving high extents of both tilt and recline in an independent manner. The three wheelchairs were identical and represented a typical host wheelchair for the purposes of the test programme.

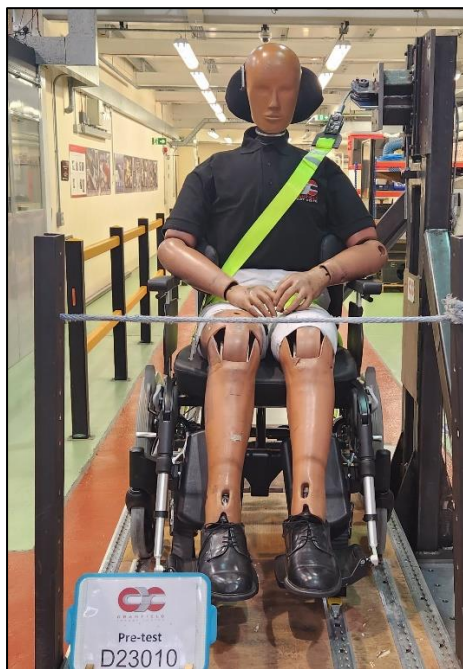
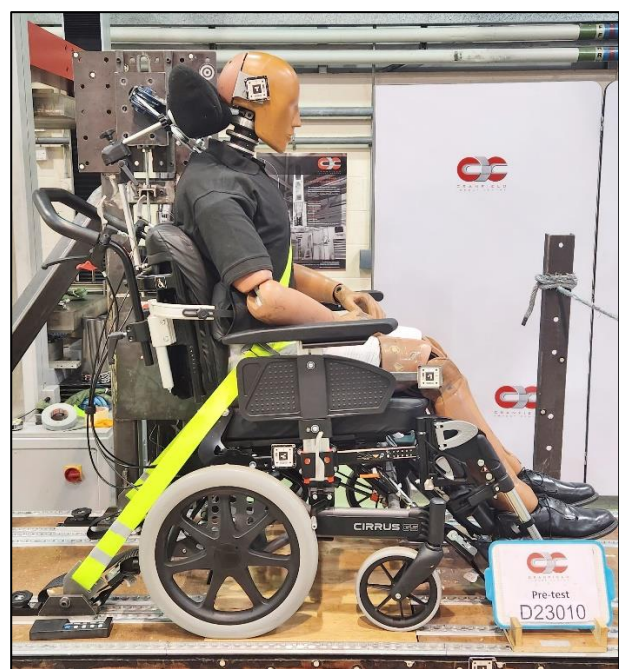
The photos below show frontal and side views of the pre-test set-up of sled run D23-010, a baseline test with seat rail at 4° and back support at 8°.

**D23-010 Baseline Test, Surrogate Vehicle Anchored Occupant Restraint System Layout**

The vehicle anchored surrogate occupant restraint system was set at idealised positions, with a lap belt to horizontal angle of 55°. Steeper angles can be achieved with some wheelchair test set-ups, however lap belt interaction with wheelchair structure frequently prevents angles greater than 55°.

The lap to shoulder belt connection point is located directly over the hip of the ATD occupant.

Upper torso restraint anchorage location is set to achieve shoulder belt application midway on the ATD clavicle, with the belt running over the mid-point of the ATD sternum.

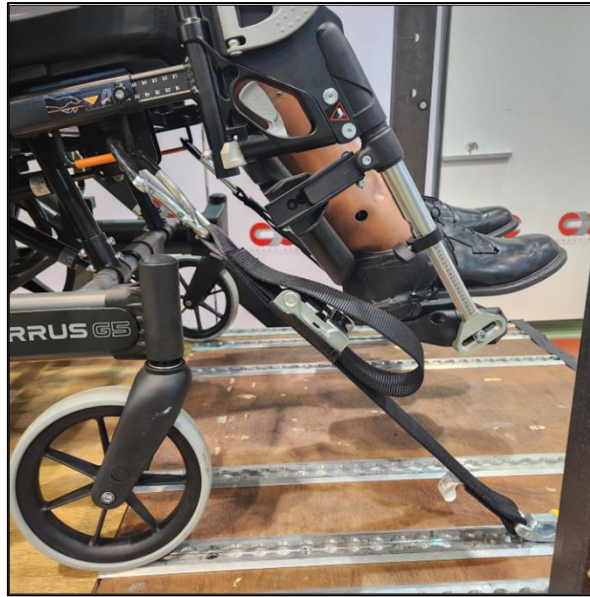
**Front tie-down arrangement.**

In all tests, the Cirrus G5 wheelchairs were secured using a commercially available webbing based four-point tie-down system, with track fittings to secure the wheelchair to the test rig surface via aluminium rail, karabiner end fittings and over-centre webbing tensioners in each of the four straps.

The front tie-downs were attached to the dedicated securement points mounted on the wheelchair seat rails.

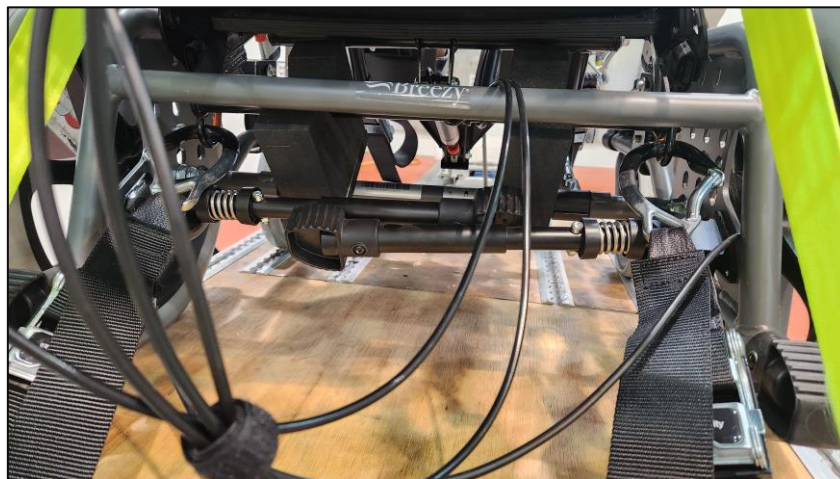
**Rear tie-down securement arrangement**

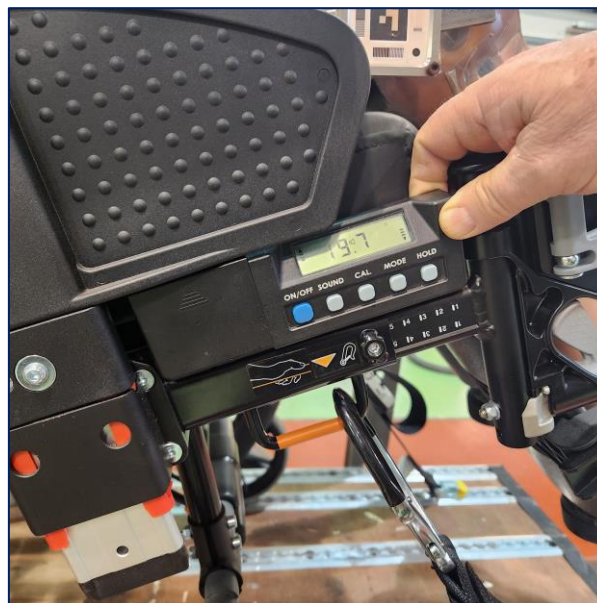
**Seat rail angle set at nominal 20° to horizontal.**

Once the ATD was positioned, the wheelchair tilt mechanism was operated to allow a nominal 20° tilt angle measured at the seat rail.

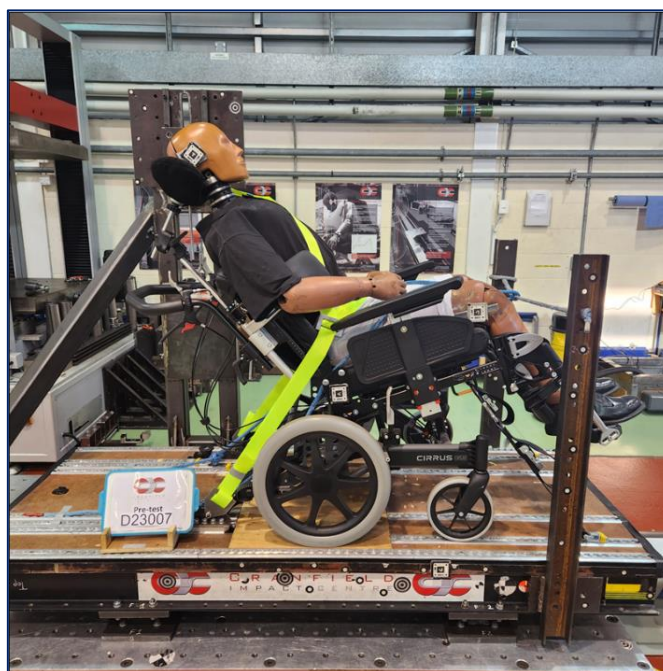
**Test 1, D23-007, Side view, pre-test**

The wheelchair was positioned on the test platform to provide correct location of the upper torso restraint anchorage surrogate and the surrogate vehicle anchored 3-point occupant restraint system fitted.

The angle of the lap belt to the horizontal was set at 55°. The junction of the shoulder to lap belt was positioned as close as possible to the H-Point of the ATD, (over the hip).

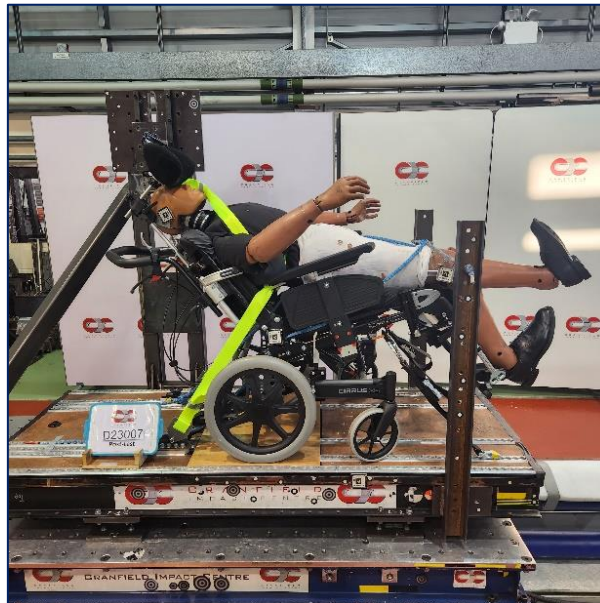
**Test 1, D23-007, Side view, post-test**

Severe abdominal intrusion occurred during the test, causing life threatening injuries to a human occupant. Poor control of upper torso during the crash simulation.

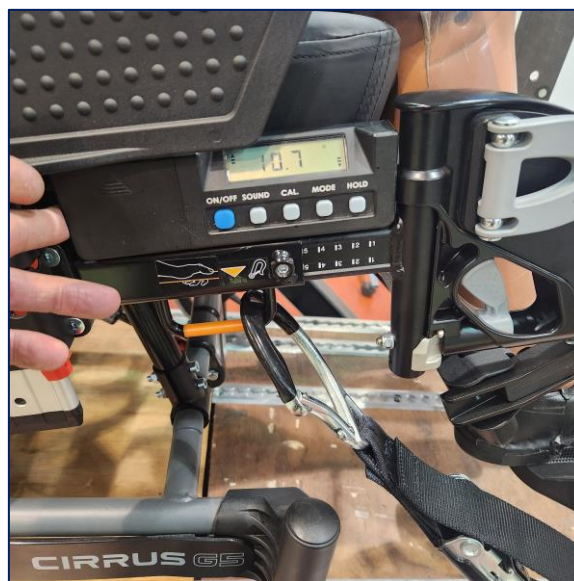
**Test 2, D23-008, Seat rail set at 10° to horizontal**

Once the ATD was positioned, the wheelchair tilt mechanism was operated to allow a nominal 10° tilt angle measured at the seat rail.

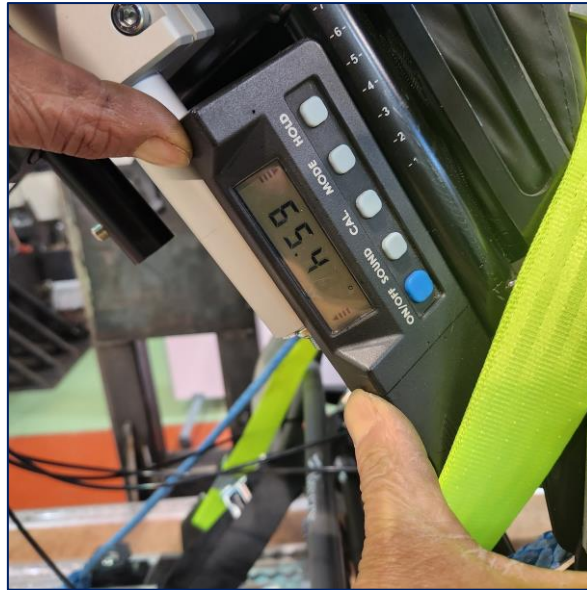
**Test 2, D23-008, Back support angle set at 25° to vertical axis (90°-65.4°)**

The adjustable back support of the Cirrus G5 was set at 15° to the vertical.

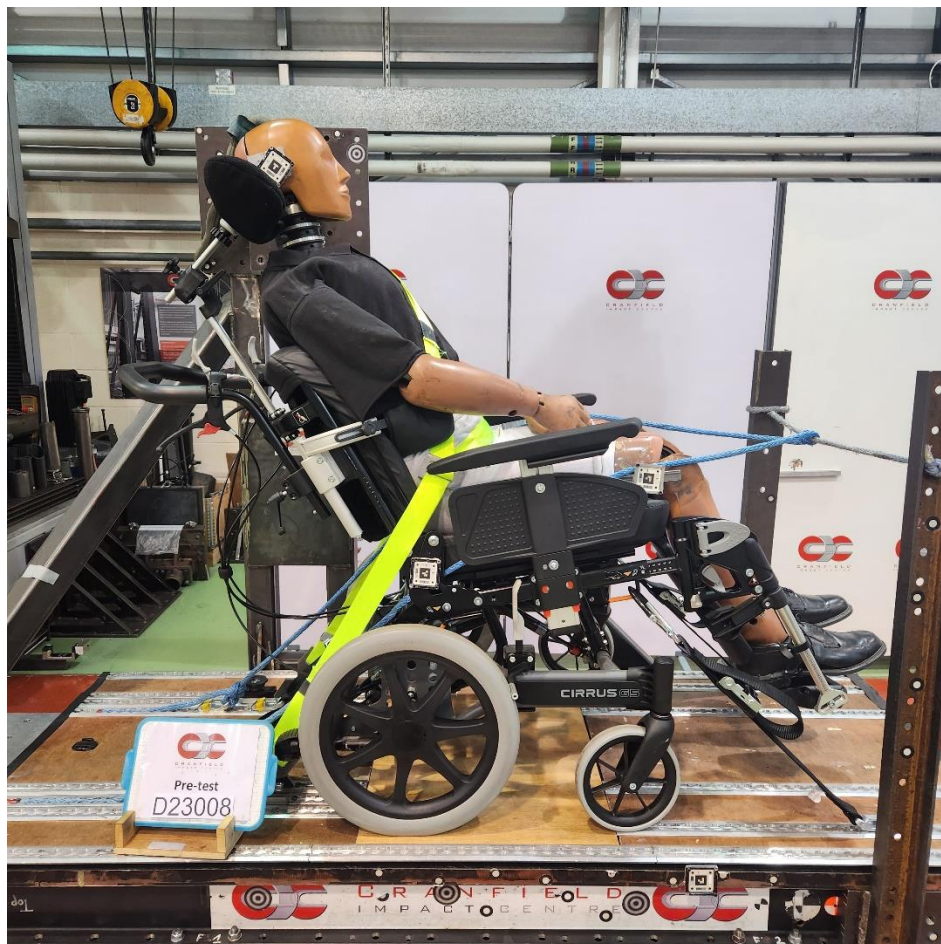
**Test 2, D23-008, Side view, pre-test**

The wheelchair was positioned on the test platform to provide correct location of the upper torso restraint anchorage surrogate and the surrogate vehicle anchored 3-point occupant restraint system fitted.

The angle of the lap belt to the horizontal was set at 55°. The junction of the shoulder to lap belt was positioned as close as possible to the H-Point of the ATD, (over the hip).

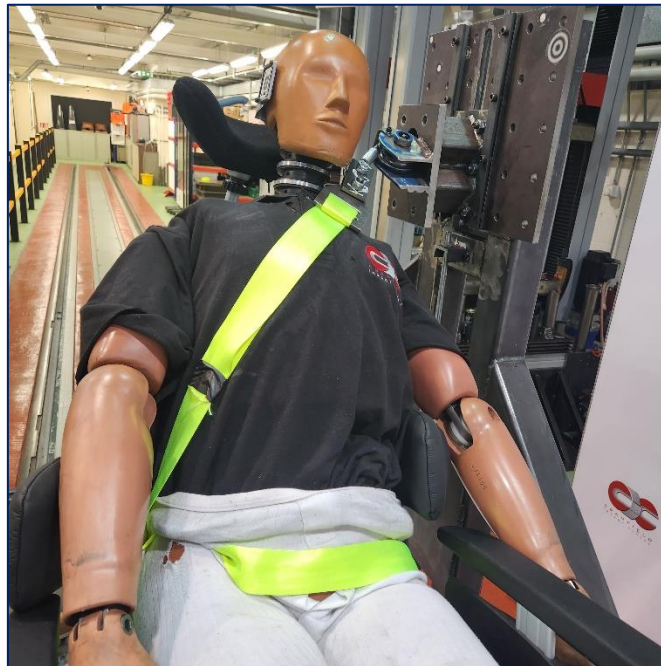
**Test 2, D23-008, Front view, post-test**

Partial abdominal intrusion occurred at right hip region. Still considered an unsatisfactory result.

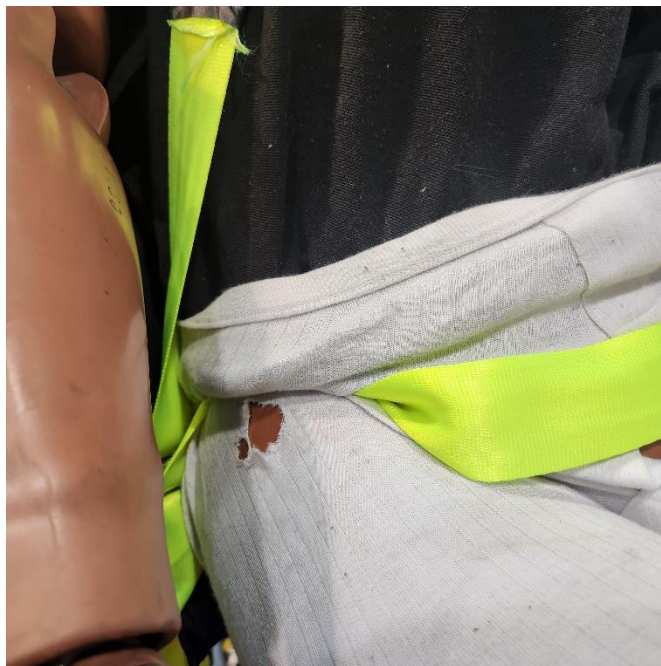
**Test 2, D23-008, lap belt position, post-test**

The outcomes of both Test 1 and Test 2 indicate poor extents of occupant retention due to poor control of the lap belt position on the pelvis of the ATD throughout the tests.

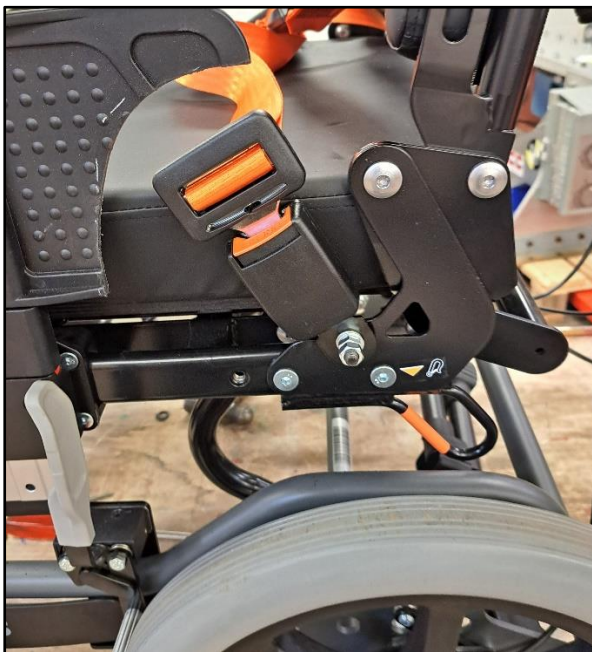
LH Side view of K12 buckle head attached to the rear tie-down securement bracket.

The mounting of two commonly available K12 seatbelt buckle blades on each side of the wheelchair was explored, allowing the creation of a wheelchair anchored lap belt, by means of attachment to the buckle heads by corresponding tongues.

The close proximity of the lap belt mounting location with the rear tie-down attachment point was considered capable of creating an acceptable load path for occupant restraint system loading.

With the seat rail horizontal at 0°, the angle of buckle alignment on the seated occupant was recorded as 63°.

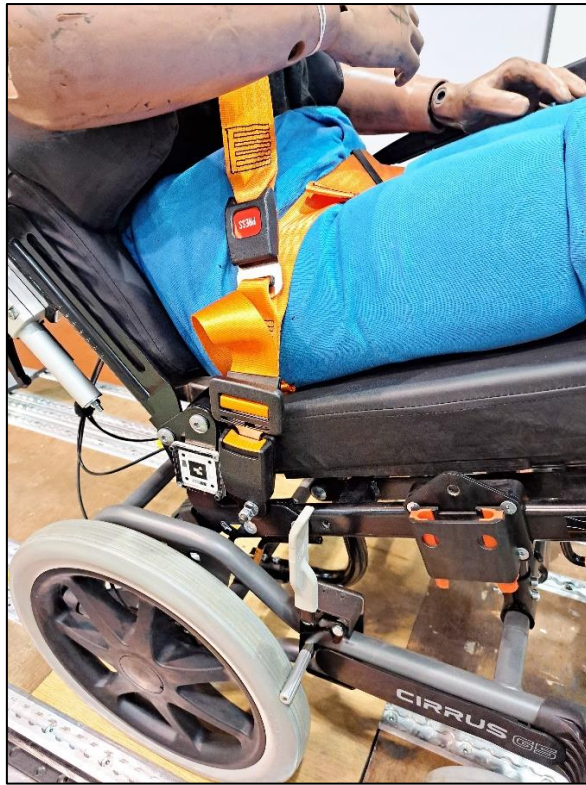
**Test 3, D23-013, RH tongue and buckle arrangement, pre-test**

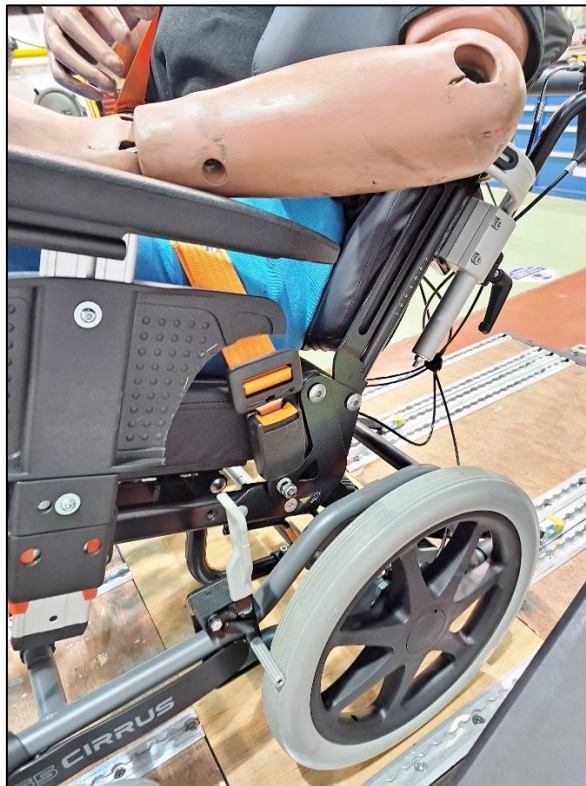
**Test 3, D23-013, LH tongue and buckle arrangement, pre-test**

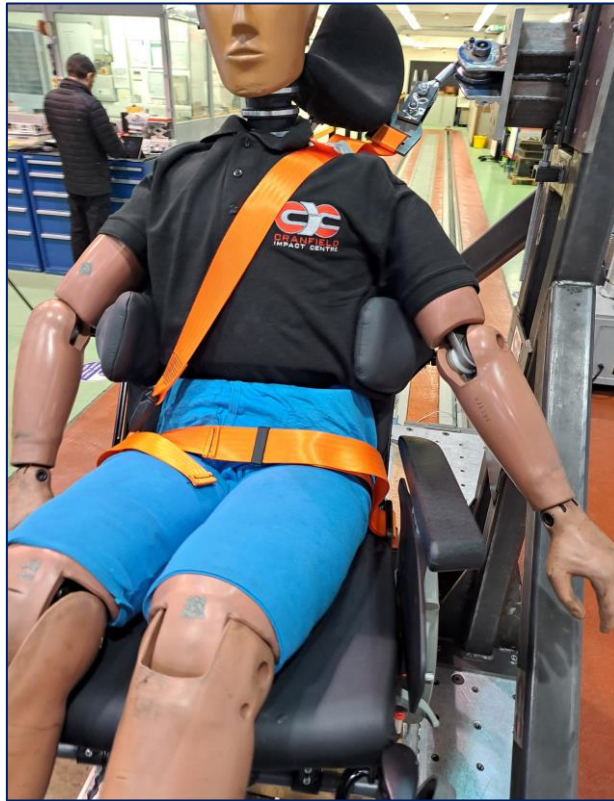
Test 3, D23-013, Front view of occupant restraint system position, post-test

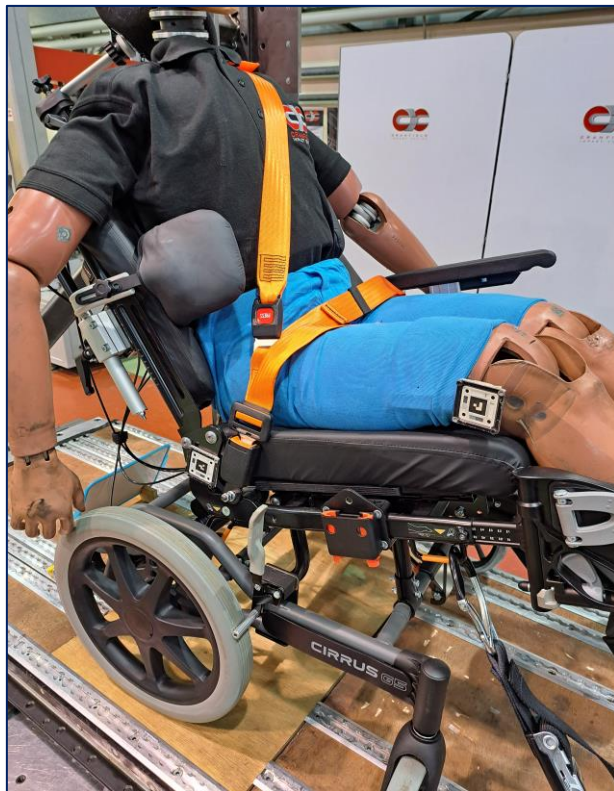
Test 3, D23-013, Front ¾ view of lap belt position on the pelvis of the ATD, post-test.

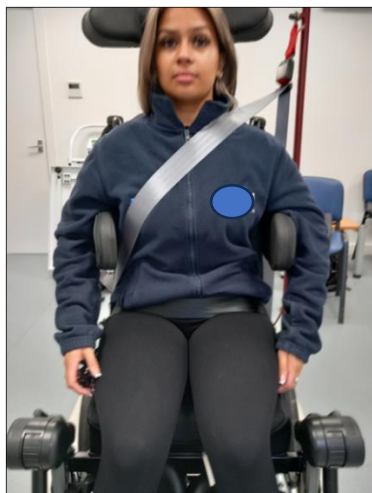
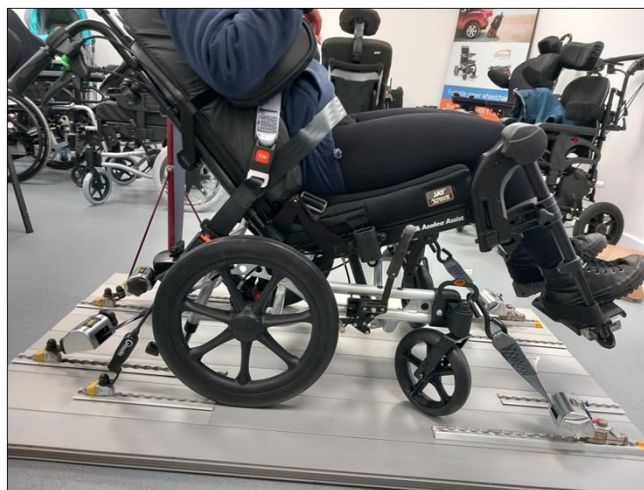
#### Wheelchair #1 – Vehicle anchored occupant restraint system

Position of the junction of lap and diagonal sections of the occupant restraint creates poor position of upper torso belt. Shallow angle of lap belt section creates a high position close to abdomen.

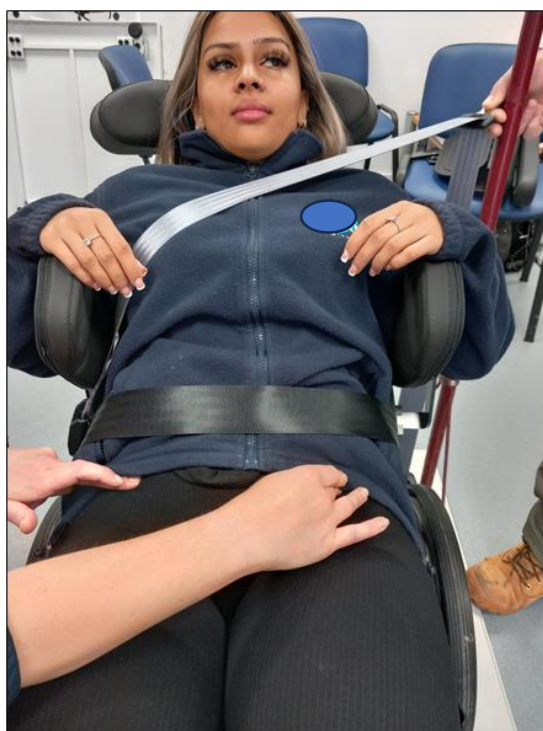
In tilt position the lap belt becomes located directly over the abdomen. Vicky's forefingers are placed on ASISs.

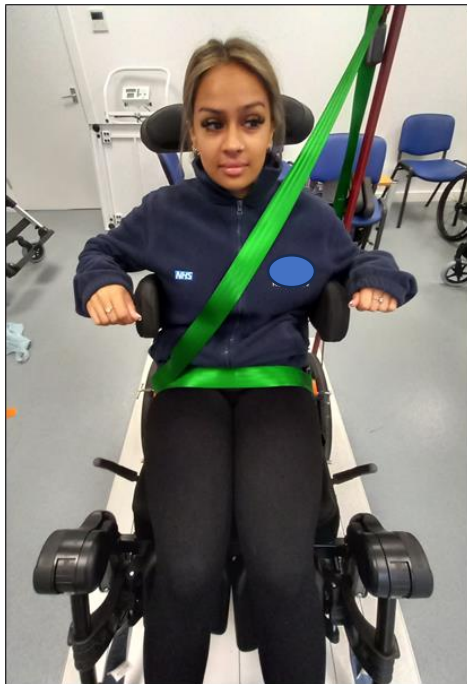
## Wheelchair #1 – Simulated wheelchair anchored lap belt with continuous 3-point restraint system

Belt positions when upright.

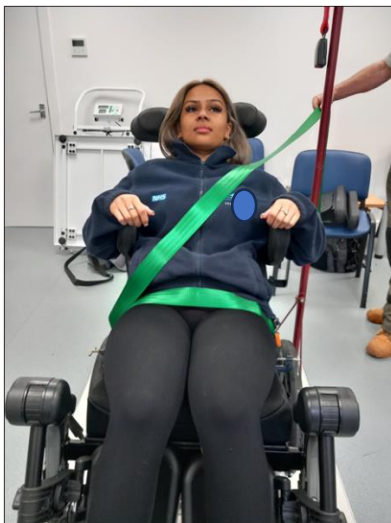
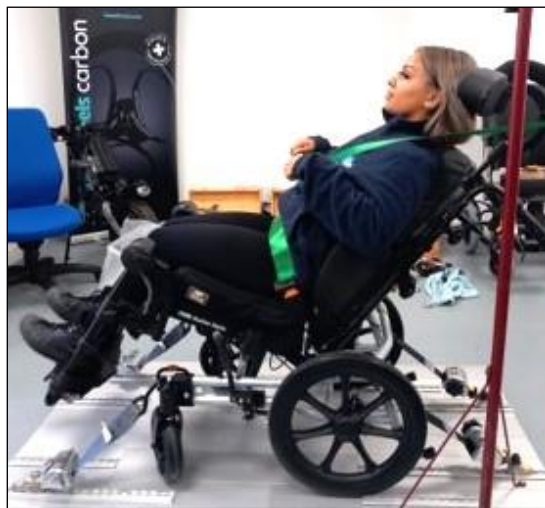
Belt positions when in tilt

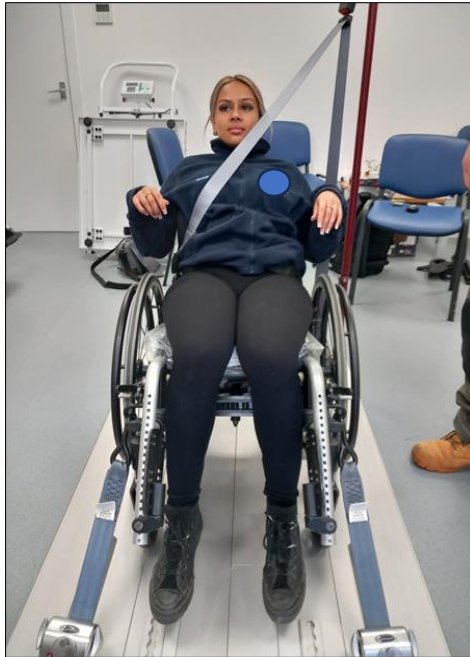
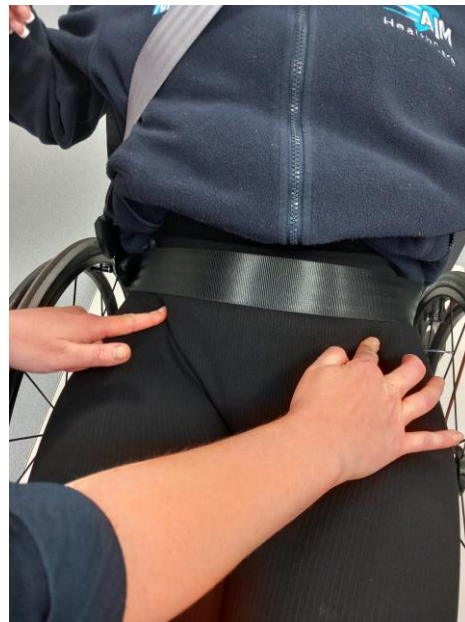
### Wheelchair #3 – Vehicle anchored occupant restraint system

Note high position of upper torso restraint and lap belt over abdomen when in tilt.

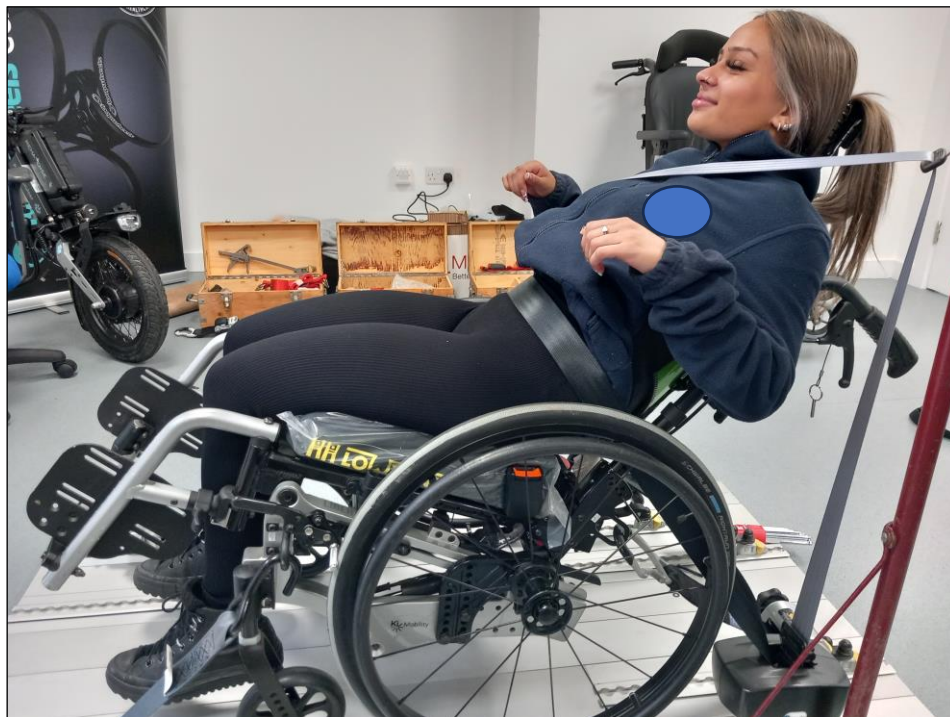
Lap belt over abdomen.

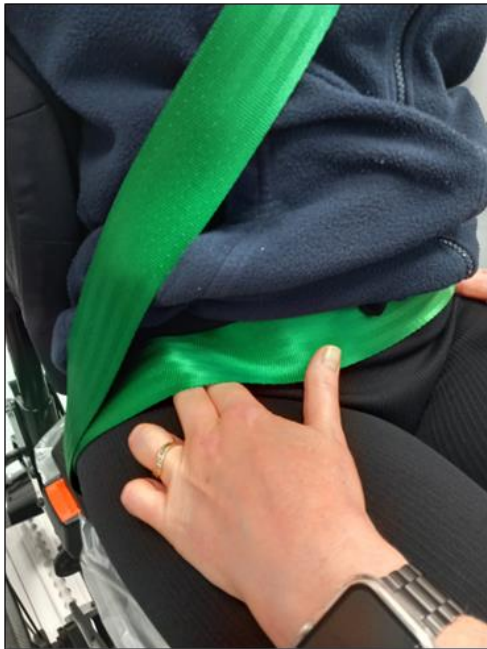
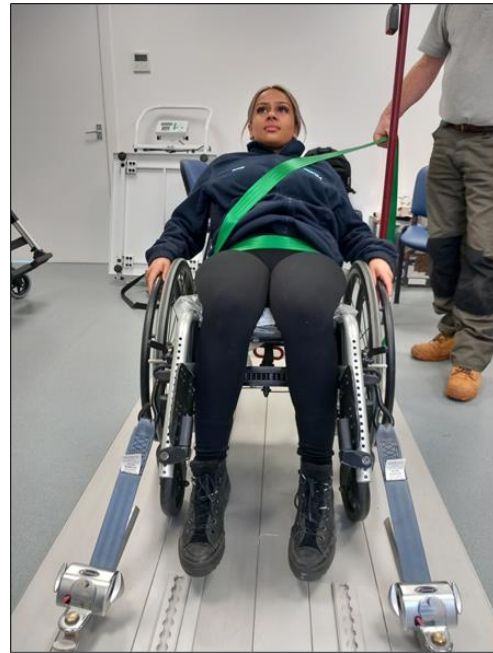
## Wheelchair #2 – Simulated wheelchair anchored lap belt with continuous 3-point restraint system

Wheelchair anchored lap belt provide excellent position over pelvis when upright.

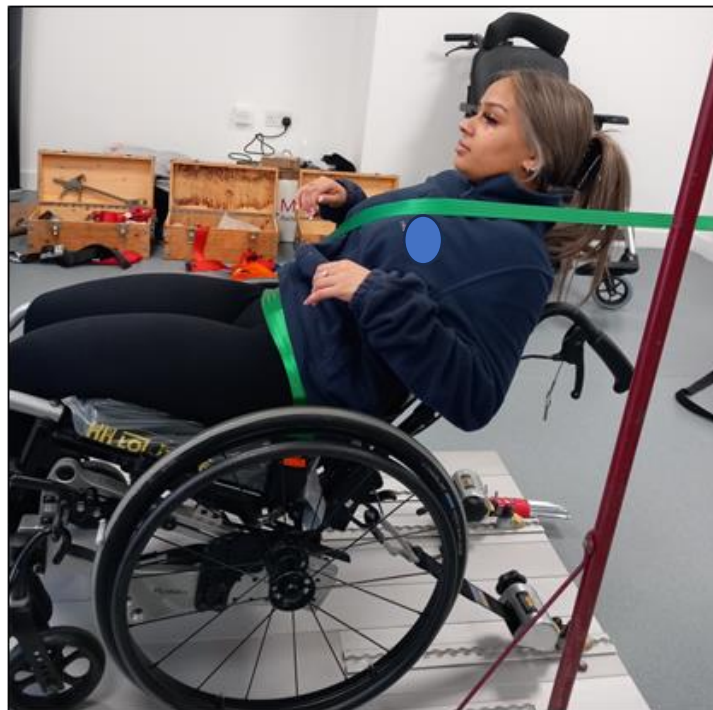
General position of occupant restraint system maintained as tilt applied.
