# Transport of wheelchair seated passengers- providing evidence of the limits of tilt and recline in transport

**Bob Appleyard: Mobility Support Services.**

**Vicky Curling: Rehabilitation Engineer**

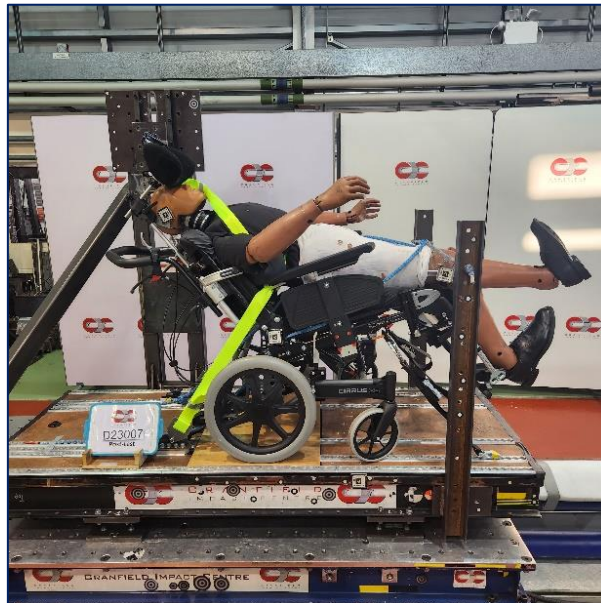
**Test 1, D23-007, Side view, post-test**

Severe abdominal intrusion occurred during the test, causing life threatening injuries to a human occupant. Poor control of upper torso during the crash simulation.

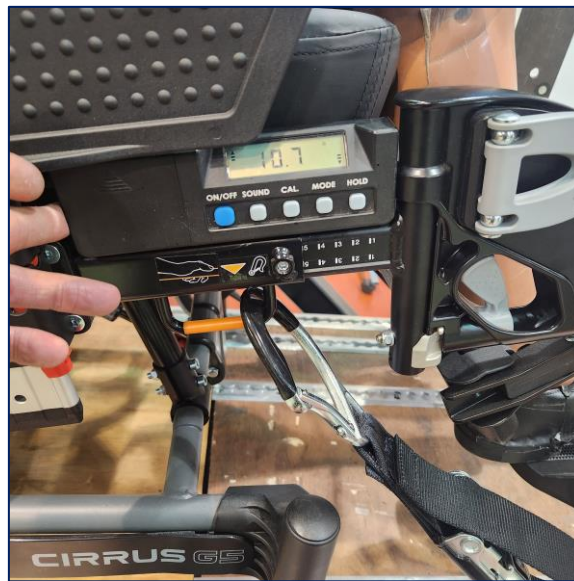
**Test 2, D23-008, Seat rail set at 10° to horizontal**

Once the ATD was positioned, the wheelchair tilt mechanism was operated to allow a nominal 10° tilt angle measured at the seat rail.

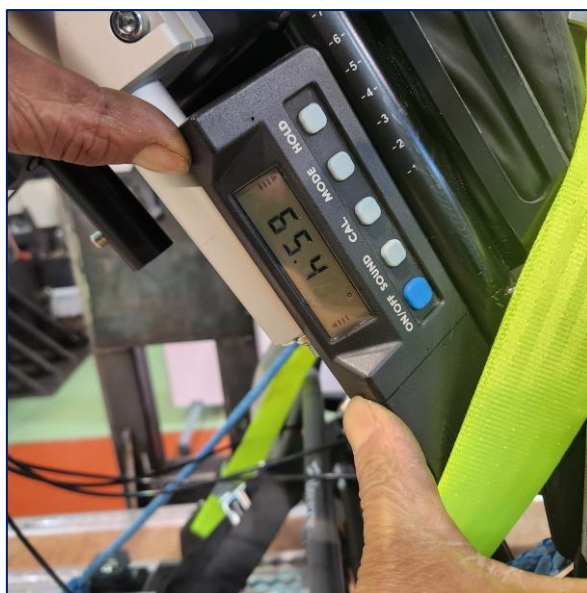
**Test 2, D23-008, Back support angle set at 25° to vertical axis (90°-65.4°)**

The adjustable back support of the Cirrus G5 was set at 15° to the vertical.

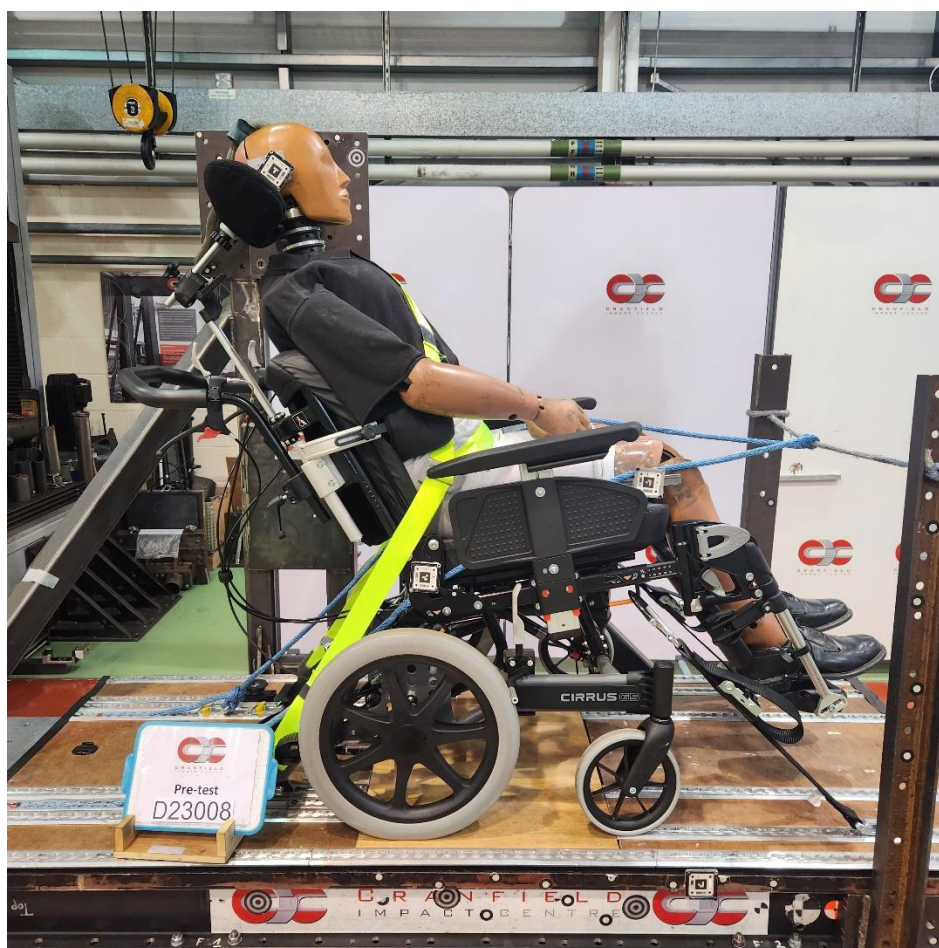
**Test 2, D23-008, Side view, pre-test**

The wheelchair was positioned on the test platform to provide correct location of the upper torso restraint anchorage surrogate and the surrogate vehicle anchored 3-point occupant restraint system fitted.

The angle of the lap belt to the horizontal was set at 55°. The junction of the shoulder to lap belt was positioned as close as possible to the H-Point of the ATD, (over the hip).

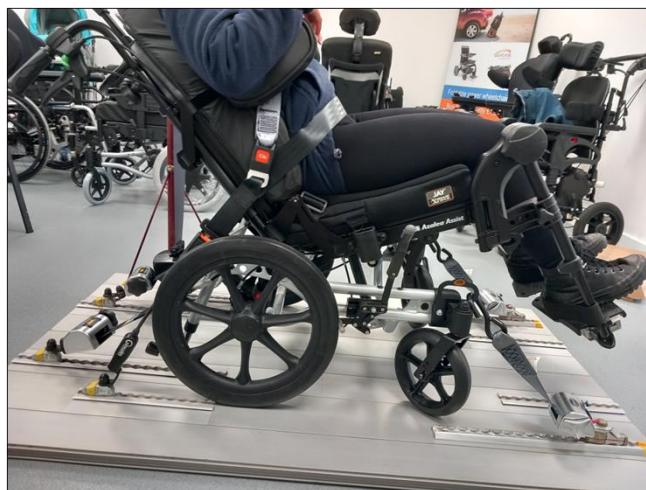
Position of the junction of lap and diagonal sections of the occupant restraint creates poor position of upper torso belt. Shallow angle of lap belt section creates a high position close to abdomen.

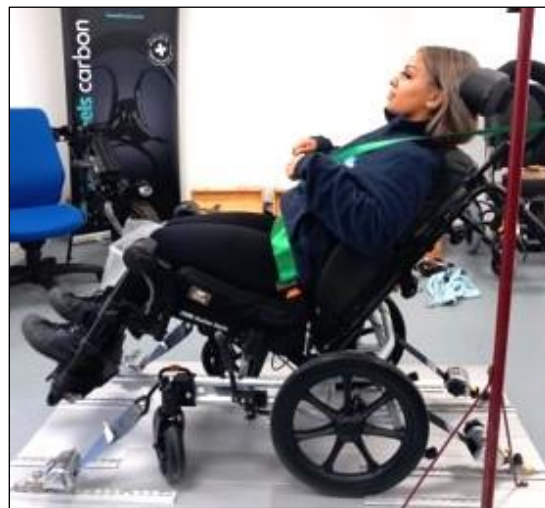
Belt positions when in tilt
